SITE CHARACTERIZATION OF A VEHICLE MAINTENANCE GARAGE

Survey Summary

Property: Vehicle Maintenance Garage

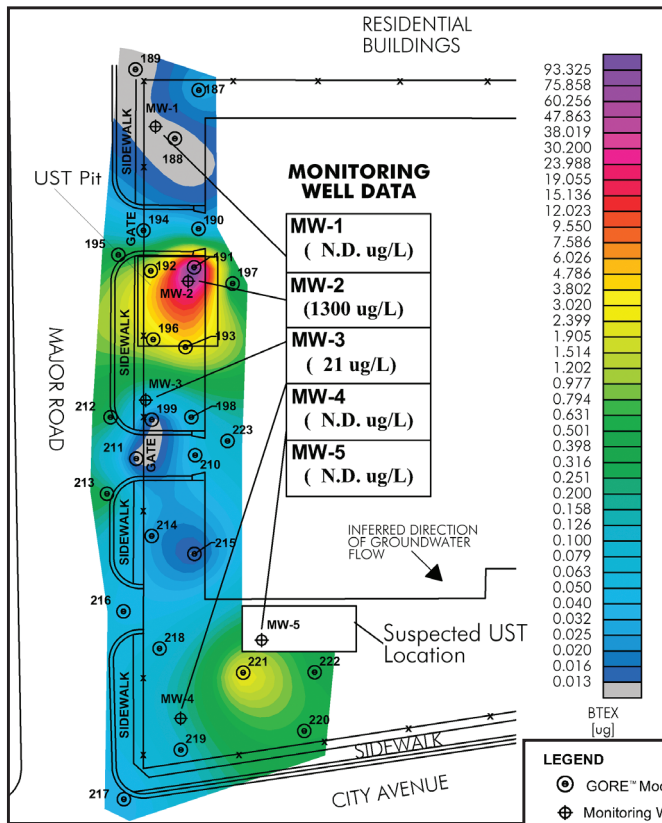
Figure 1. AGI Survey - BTEX Results

The AGI Survey revealed the presence of two BTEX plumes (Fig. 1): one in an area of known USTs; the other, a less intense BTEX plume, in an area where an older UST was later identified. MtBE was also observed in the soil gas (Fig. 2), and appeared to “lead” the BTEX plume, as elevated levels were located away from the source at the time of the survey. As a result of the AGI Survey, optimized installations sites were identified for five monitoring wells. Soil borings analyzed for BTEX yielded non-detectable levels. However, water quality data from the monitoring wells compared favorably with the Gore™ Survey (Fig. 1).
